**Flood Control Project Maintenance  
Levee Inspections****LMA District Cover Sheet****Spring 2014 Levee Inspection Results****Reclamation District No. 0827 Elkhorn**

## Levee Inspection Report By Mile - Spring 2014

### Reclamation District No. 0827 Elkhorn

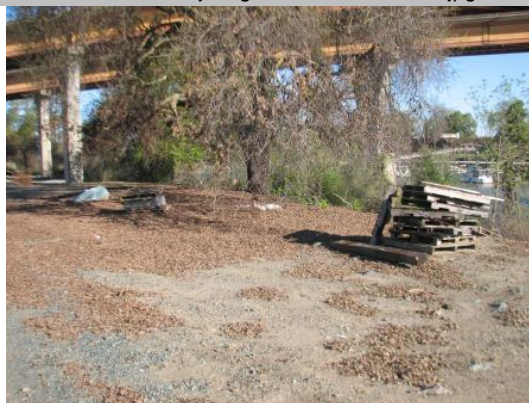
Photo 1 of 1 : johngw\_s\_20140324\_652.jpg

LM Start	0.23	Rating **	M	Issue No.	108
LM End	0.23	Issue Type +	En	Location *	CR
Category	Earthen Levee			GPS Latitude/Longitude	
				Start	End
Item	Encroachments			38.672654 °	38.672654 °
				-121.627242 °	-121.627242 °
DWR ID	DWR_RD0827_01_s_2014_108				
Action/Comments					
Debris

Pallets and debris from the rail road left on levee crown. Spring 2014

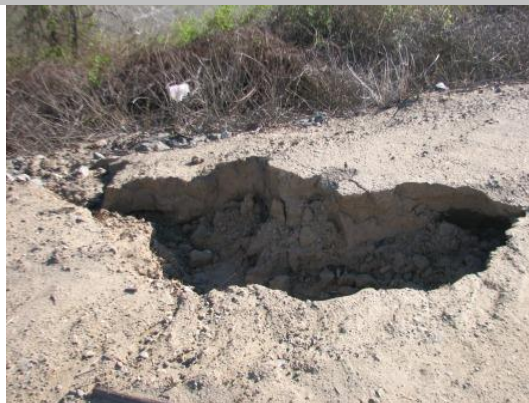
Photo 1 of 1 : johngw\_s\_20140324\_653.jpg

Erosion on the waterside shoulder 1'-2' deep. Spring 2014

LM Start	0.27	Rating **	M	Issue No.	109
LM End	0.27	Issue Type +	Ma	Location *	WS
Category	Earthen Levee			GPS Latitude/Longitude	
				Start	End
Item	Erosion / Bank Caving			38.672406 °	38.672406 °
				-121.626828 °	-121.626828 °
DWR ID	DWR_RD0827_01_s_2014_109				
Action/Comments					
Note and monitor erosion site.

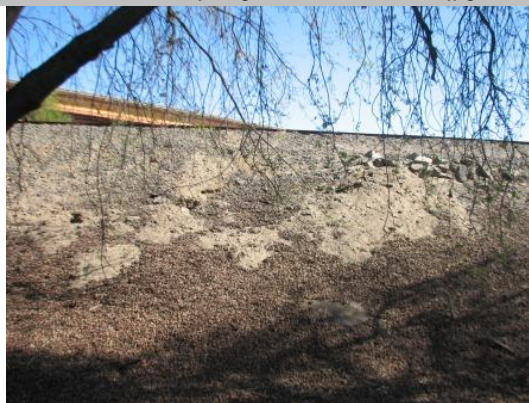
Photo 1 of 1 : johngw\_s\_20140324\_654.jpg

Some rodent damage on the landside levee slope. Spring 2014

LM Start	0.28	Rating **	M	Issue No.	112
LM End	0.28	Issue Type +	Ma	Location *	LS
Category	Earthen Levee			GPS Latitude/Longitude	
				Start	End
Item	Animal Control			38.672170 °	38.672170 °
				-121.627049 °	-121.627049 °
DWR ID	DWR_RD0827_01_s_2014_112				
Action/Comments					
Repair the levee slope damaged by livestock and prevent large animal access.

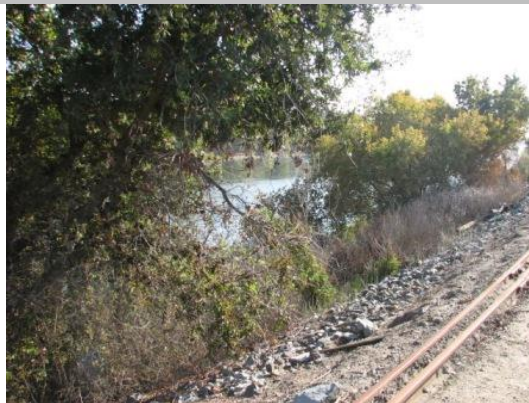
Photo 1 of 2 : johngw\_s\_20140306\_982.jpg

Thick vegetation on the waterside. Fall 2011

LM Start	0.31	Rating **	A/W	Issue No.	2
LM End	0.37	Issue Type +	Ob	Location *	WS
Category	Earthen Levee			GPS Latitude/Longitude	
				Start	End
Item	Trim / Thin Trees			38.671959 °	38.671376 °
				-121.626305 °	-121.625608 °
DWR ID	DWR_RD0827_01_s _ 2012_2				
Action/Comments					
Thin trees to allow visibility of the ground and room to flood fight.

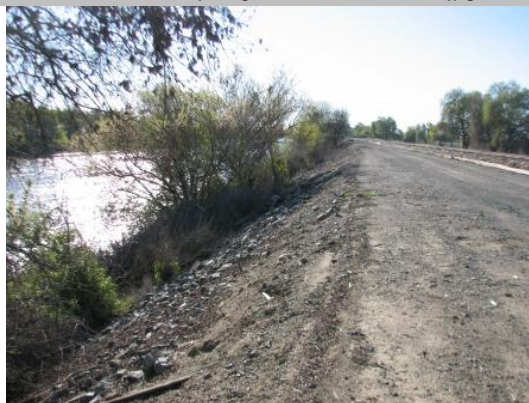
Photo 2 of 2 : johngw\_s\_20140324\_655.jpg

Vegetation is at least 20 feet down the levee slope with trees along the waterside. Spring 2014

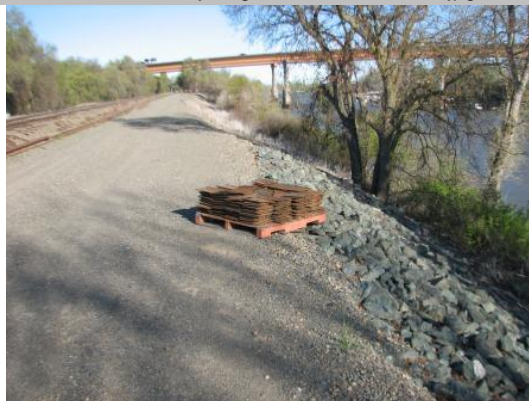
Photo 1 of 1 : johngw\_s\_20140324\_656.jpg

LM Start	0.42	Rating **	M	Issue No.	110
LM End	0.42	Issue Type +	En	Location *	CR
Category	Earthen Levee			GPS Latitude/Longitude	
				Start	End
Item	Encroachments			38.670829 °	38.670829 °
				-121.624921 °	-121.624921 °
DWR ID	DWR_RD0827_01_s _ 2014_110				
Action/Comments					
Debris

Debris from the railroad is stacked along the crown shoulder. Spring 2014

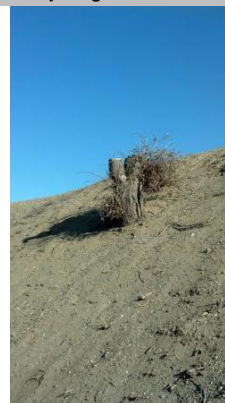
Photo 1 of 1 : johngw\_s\_20140306\_983.jpg

LM Start	0.54	Rating **	N	Issue No.	13
LM End	0.54	Issue Type +	Ma	Location *	LS
Category	Earthen Levee			GPS Latitude/Longitude	
				Start	End
Item	Trim / Thin Trees			38.669445 °	38.669445 °
				-121.623574 °	-121.623574 °
DWR ID	DWR_RD0827_01_s _ 2012_13				
Action/Comments					
Tree stumps.

A tree stump on the levee slope. Photo fall 2012.

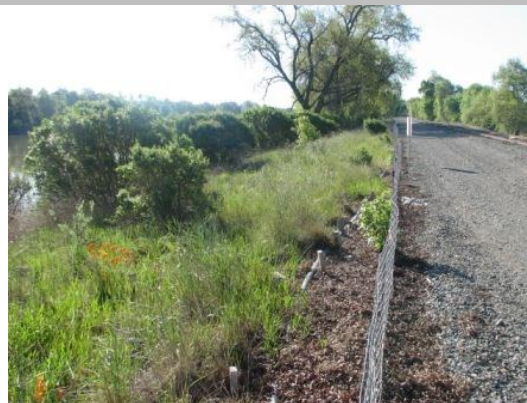
Photo 1 of 5 : johngw\_s\_20140306\_984.jpg

Revegetaion site with fencing, irrigation and stakes to hold netting.  
Photo taken spring 2012.

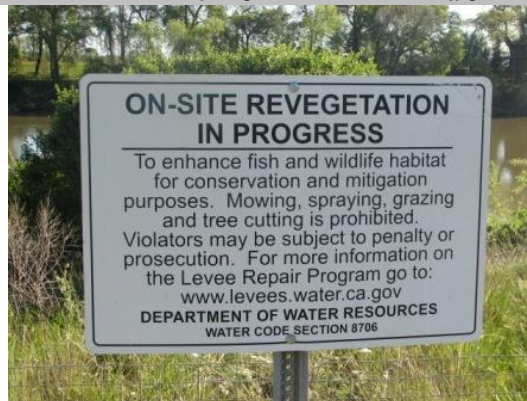
Photo 2 of 5 : johngw\_s\_20140306\_985.jpg

Revegetation site spring 2012.

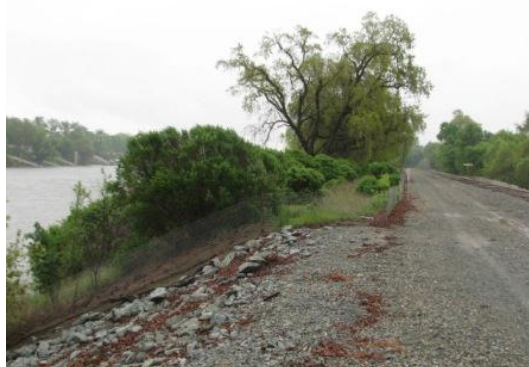
Photo 3 of 5 : johngw\_s\_20140306\_986.jpg

The revegetation site has grown and blocks visibility. Spring 2013

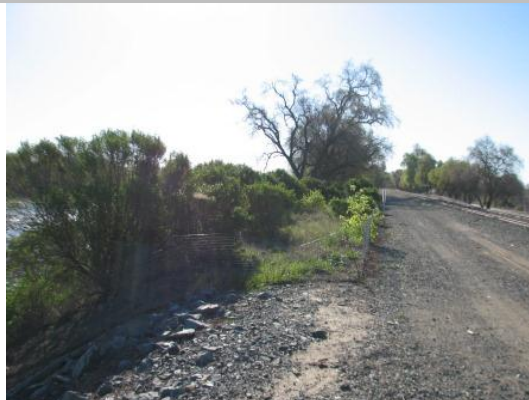
Photo 4 of 5 : johngw\_s\_20140324\_657.jpg

The vegetation continues to grow taller. It makes visibility hard. Spring 2014

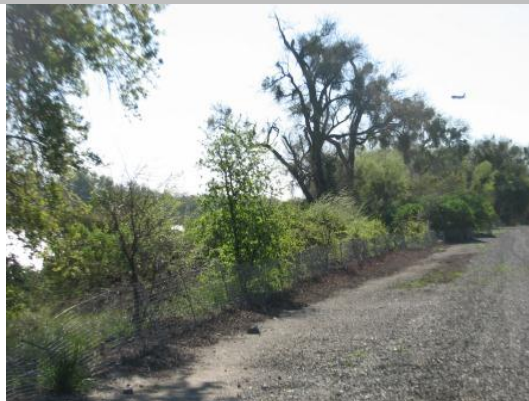
Photo 5 of 5 : johngw\_s\_20140324\_658.jpg

Another view of the revegetation site. Spring 2014

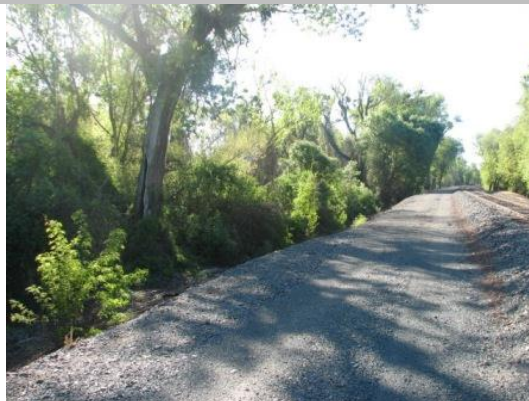
Photo 1 of 1 : johngw\_s\_20140306\_987.jpg

LM Start	0.92	Rating **	A/W	Issue No.	23
LM End	1.33	Issue Type +	Ma	Location *	WS
Category	Earthen Levee			GPS Latitude/Longitude	
				Start	End
Item	Vegetation			38.665777 °	38.661267 °
				-121.618523 °	-121.613803 °
DWR ID	DWR_RD0827_01_s _ 2012_23				
Action/Comments					
Trees / Woody Vegetation

Trees on the very wide waterside berm. Photo taken spring 2012.

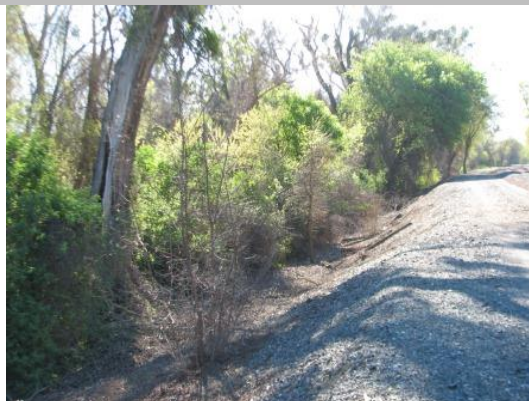
Photo 1 of 1 : johngw\_s\_20140324\_659.jpg

The vegetation is clear on the levee slope. Spring 2014

LM Start	1.10	Rating **	A	Issue No.	111
LM End	1.28	Issue Type +	Ma	Location *	WS
Category	Earthen Levee			GPS Latitude/Longitude	
				Start	End
Item	Vegetation			38.663862 °	38.661863 °
				-121.616389 °	-121.614378 °
DWR ID	DWR_RD0827_01_s _ 2014_111				
Action/Comments					
Control annual grass and weeds on the levee slopes and easements.

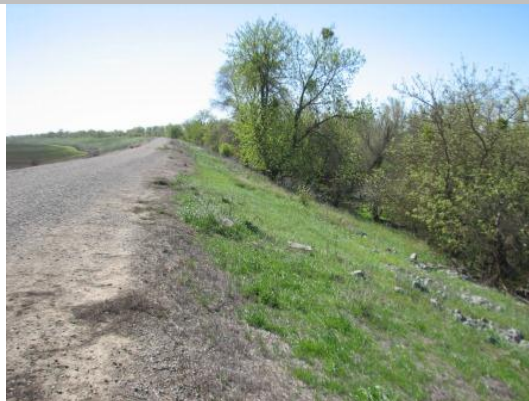
Photo 1 of 1 : johngw\_s\_20140324\_660.jpg

Control tall grasses along the waterside slope. Spring 2014

LM Start	0.01	Rating **	M	Issue No.	198
LM End	2.76	Issue Type +	Ma	Location *	WS
Category	Earthen Levee			GPS Latitude/Longitude	
				Start	End
Item	Vegetation			38.676447 °	38.641923 °
				-121.642778 °	-121.620883 °
DWR ID	DWR_RD0827_02_s_2014_198				
Action/Comments					
Control annual grass and weeds on the levee slopes and easements.

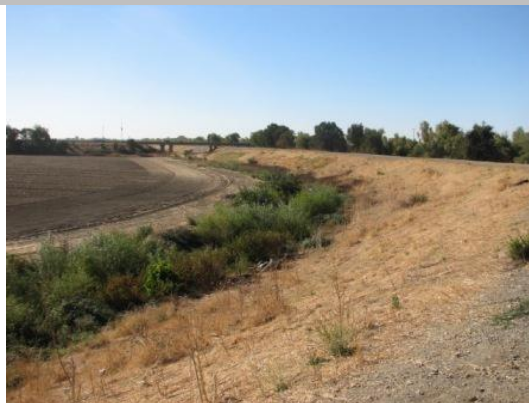
Photo 1 of 2 : johngw\_s\_20140306\_989.jpg

LM Start	0.01	Rating **	M	Issue No.	2
LM End	0.53	Issue Type +	En	Location *	LS
Category	Earthen Levee			GPS Latitude/Longitude	
				Start	End
Item	Encroachments			38.676440 °	38.669401 °
				-121.642747 °	-121.641417 °
DWR ID	DWR_RD0827_02_f_2012_2				
Action/Comments					
Ditch

Ditch runs along the landside toe. Photo fall 2012.

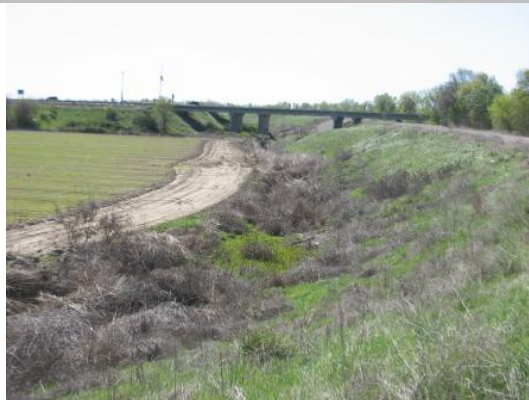
Photo 2 of 2 : johngw\_s\_20140324\_661.jpg

The ditch run along the landside slope. Spring 2014

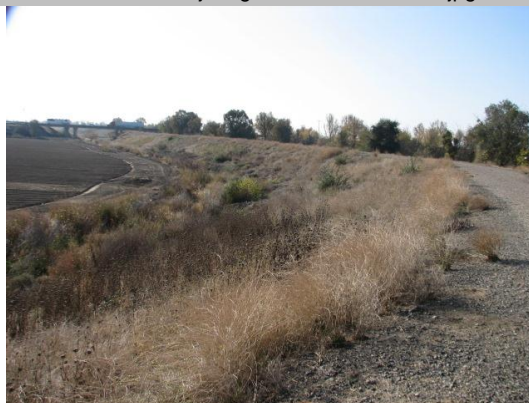
Photo 1 of 2 : johngw\_s\_20140306\_993.jpg

Tall grasses and weeds block visibility of the levee slope. Fall 2013

LM Start	0.02	Rating **	M	Issue No.	6
LM End	2.78	Issue Type +	Ma	Location *	LS
Category	Earthen Levee			GPS Latitude/Longitude	
				Start	End
Item	Vegetation			38.676470 °	38.641780 °
				-121.642745 °	-121.620784 °
DWR ID	DWR_RD0827_02_f_2013_6				
Action/Comments					
Control annual grass and weeds on the levee slopes and easements.

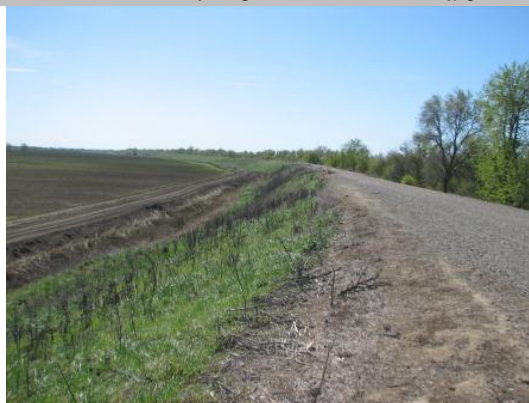
Photo 2 of 2 : johngw\_s\_20140324\_662.jpg

Control tall grasses along the landside levee slope. Spring 2014

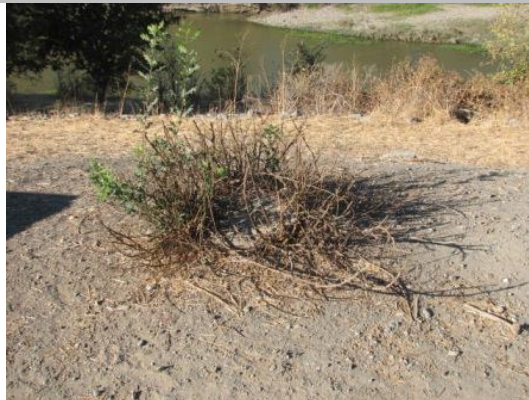
Photo 1 of 1 : johngw\_s\_20140306\_991.jpg

LM Start	0.11	Rating **	N	Issue No.	4
LM End	0.11	Issue Type +	Ma	Location *	CR
Category	Earthen Levee			GPS Latitude/Longitude	
				Start	End
Item	Trim / Thin Trees			38.675236 °	38.675236 °
				-121.642985 °	-121.642985 °
DWR ID	DWR_RD0827_02_s_2012_4				
Action/Comments					
Tree stumps.

A tree stump on the levee shoulder. Photo fall 2012.

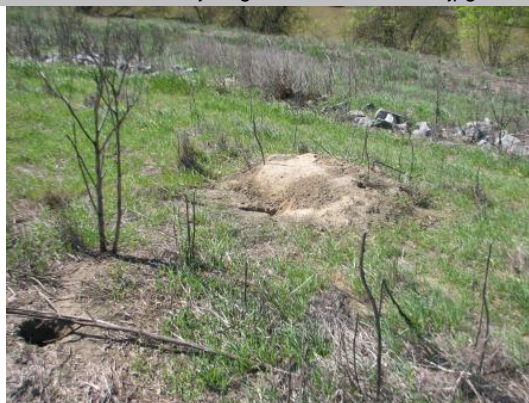
Photo 1 of 1 : johngw\_s\_20140324\_664.jpg

A large rodent hole on the waterside levee slope. Spring 2014

LM Start	0.65	Rating **	M	Issue No.	197
LM End	0.65	Issue Type +	Ma	Location *	WS
Category	Earthen Levee			GPS Latitude/Longitude	
				Start	End
Item	Animal Control			38.667872 °	38.667872 °
				-121.640599 °	-121.640599 °
DWR ID	DWR_RD0827_02_s_2014_197				
Action/Comments					
Repair the levee slope damaged by livestock and prevent large animal access.

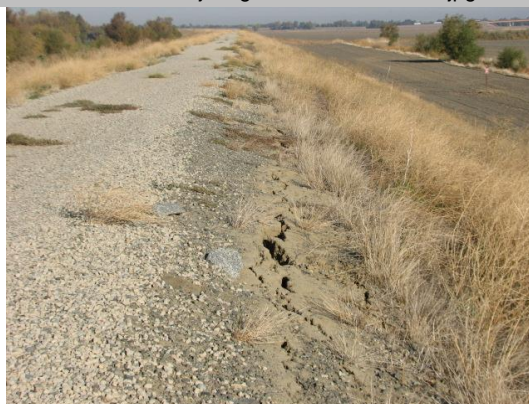
Photo 1 of 1 : johngw\_s\_20140306\_992.jpg

The crack is 4-6 inches wide and 3 feet deep with a length of 6 feet. Fall 2013

LM Start	2.03	Rating **	U	Issue No.	5
LM End	2.16	Issue Type +	Ob	Location *	CR
Category	Earthen Levee			GPS Latitude/Longitude	
				Start	End
Item	Cracking			38.651316 °	38.649804 °
				-121.626680 °	-121.625759 °
DWR ID	DWR_RD0827_02_f_2013_5				
Action/Comments					
Monitor and have inspected by geotechnical engineer.

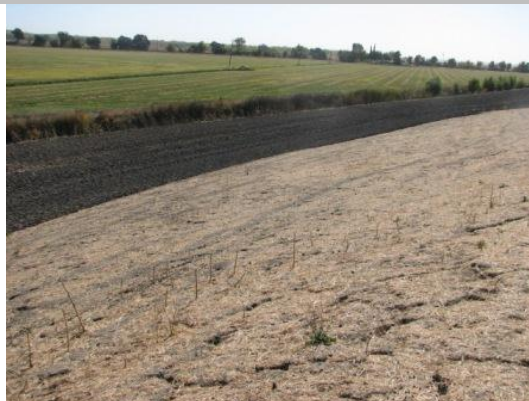
Photo 1 of 1 : johngw\_s\_20140306\_995.jpg

A bulge in the levee slope. Photo fall 2012.

LM Start	2.31	Rating **	M	Issue No.	24
LM End	2.31	Issue Type +	Ma	Location *	LS
Category	Earthen Levee			GPS Latitude/Longitude	
				Start	End
Item	Slope Stability			38.647703 °	38.647703 °
				-121.624450 °	-121.624450 °
DWR ID	DWR_RD0827_02_s _ 2012_24				
Action/Comments					
Repair slope instability. Inspector Comments: There is cracking along the levee slope not greater than 200 feet. Need to monitor.

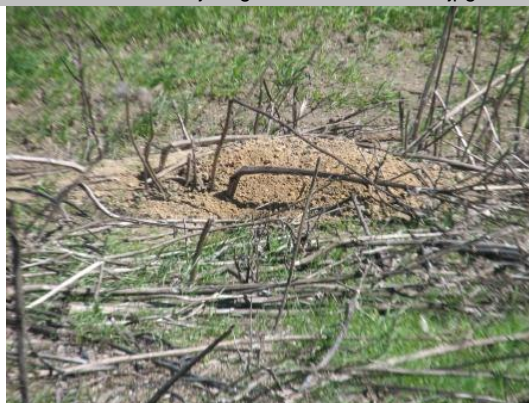
Photo 1 of 1 : johngw\_s\_20140324\_665.jpg

A rodent hole on the landside levee slope. Spring 2014

LM Start	2.69	Rating **	M	Issue No.	199
LM End	2.69	Issue Type +	Ma	Location *	LS
Category	Earthen Levee			GPS Latitude/Longitude	
				Start	End
Item	Animal Control			38.643002 °	38.643002 °
				-121.621536 °	-121.621536 °
DWR ID	DWR_RD0827_02_s _ 2014_199				
Action/Comments					
Repair the levee slope damaged by livestock and prevent large animal access.
